Wronska, Urszula and Ryan, Brendan (2017) Using contextual information in the evaluation of the effectiveness of barriers restricting access to the main line at stations. In: 6th International Human Factors Rail Conference, 6-9 Nov 2017, London, UK.

Urszula WRONSKA, Brendan RYAN

*University of Nottingham, United Kingdom*

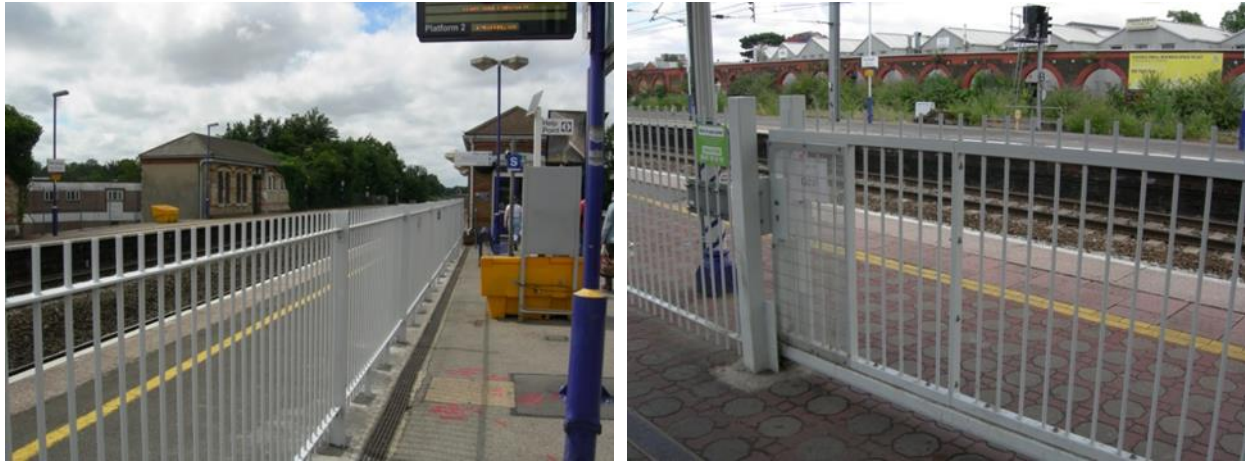
*Figures 1 and 2. Mid-platform fencing, separating a fast line platform from the slow line platform and a sliding gate in the mid-platform fencing*

Fencing is used in many locations to prevent access to the railway, with examples at platform ends or along the perimeter of the railway. In Great Britain, analysis within the industry identified that there was a disproportionate number of incidents on fast lines, often at island platforms, at stations where trains do not typically stop. Several programmes of work have taken place in the last ten years to fit mid-platform fencing, an example of which is shown in Figure 1. This fencing allows passengers to access the slow line of the island platform, but prevents access to the fast line platform. The fencing is fitted with gates, as shown in Figure 2, in order to enable people to get access to and from the fast line platform in various circumstances (e.g. in times of disruption where there are unusual stopping patterns). The gates are usually locked during the daytime when the station may be staffed, but unlocked to allow access for legitimate purposes at night time. In order for the fencing to provide an effective barrier to access it needs to be fitted to a suitable standard and be complete (e.g. securing against access along the length of the platform and joining with existing or newly fitted platform end fencing). There are commonly two fast lines at stations (running in opposite directions) and fencing programmes also need to include works to fit new fencing and secure existing access points to other fast line platforms where trains do not routinely stop (e.g. at gates at alternative entrances to stations).
